## **Libeň Bridge (V009) Society**

**Expert report No. 1700 J 019-01**

**Determination of Loadability of Libeň Bridge V009 and Assessment of Individual  
Construction Elements in Terms of Feasibility, Applicability, Service Life and Potential  
Repair Works**

**SUMMARY REPORT**

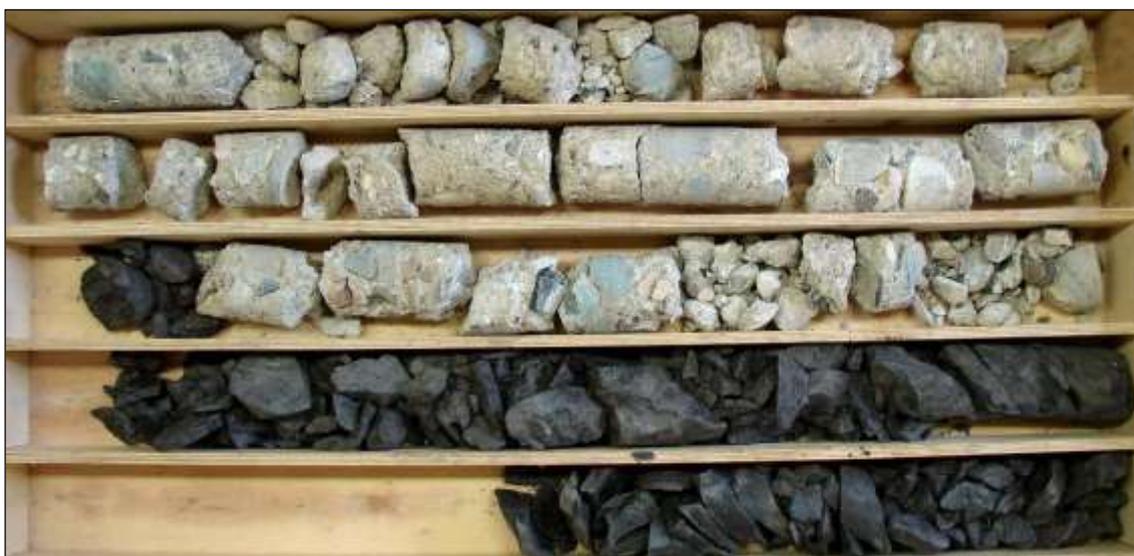
- h) The columns and abutments of the vault bridge are built on shale bedrock (rock type R4, and R4/R5). Calculation value of the bedrock load-bearing capacity recommended for the static analysis is  $R_d = 800$  kPa.

**Fig. 9:** Porous and little cohesive concrete in foundations of the column of the vault part and bedrock

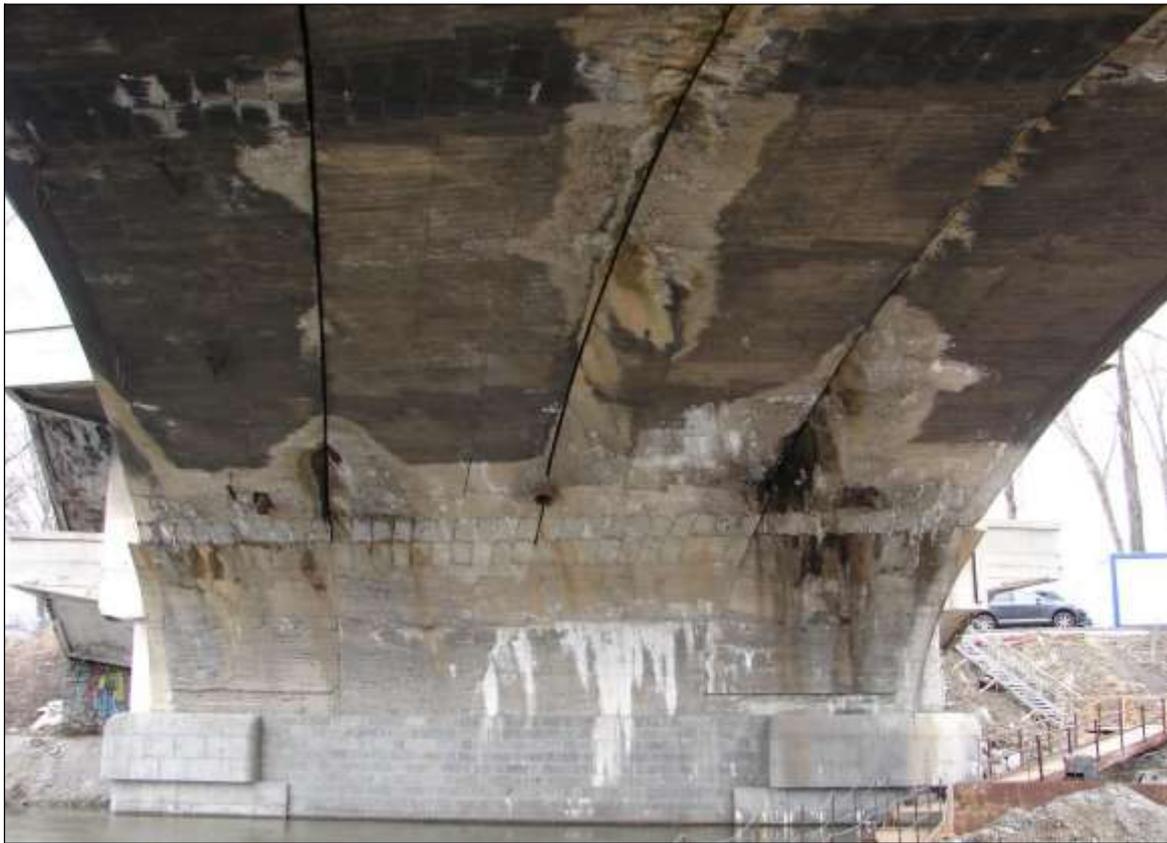
- c) 20-25 % of the surface of the concrete used in the vaults, columns and abutments suffer from corrosive degradation as deep as 10 to 30 mm caused by exposure to water leakages and frost. In some areas around gravel pockets severely affected by intense water leakages, i.e. around drainage holes, corrosive degradation has penetrated as deep as 100 mm.

**Fig. 10:** Concrete degradation in the vaults and abutments caused by water leakages in conjunction with frost

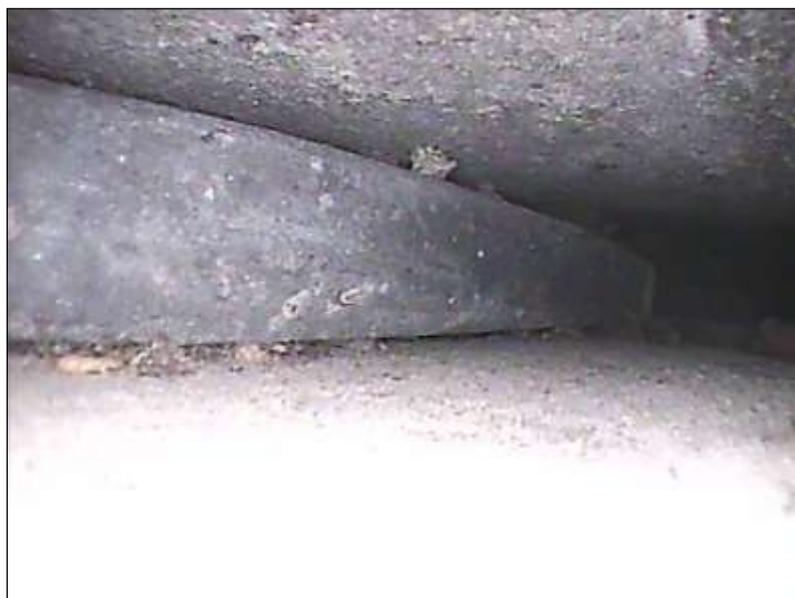
- d) Endoscopic inspection of selected plumb slabs in the vault joints did not reveal any discernible form of deformation.
- e) Insulation of the vault part is damaged (completely consumed by corrosion) in areas where the insulation material stretches across the joints connecting several vault slabs (approximately 50 % of their length). Insulation of the frame structures is damaged especially in areas around the expansion and deck joints.

**Fig. 11:** Plumb slabs in the vault joints without any apparent damage

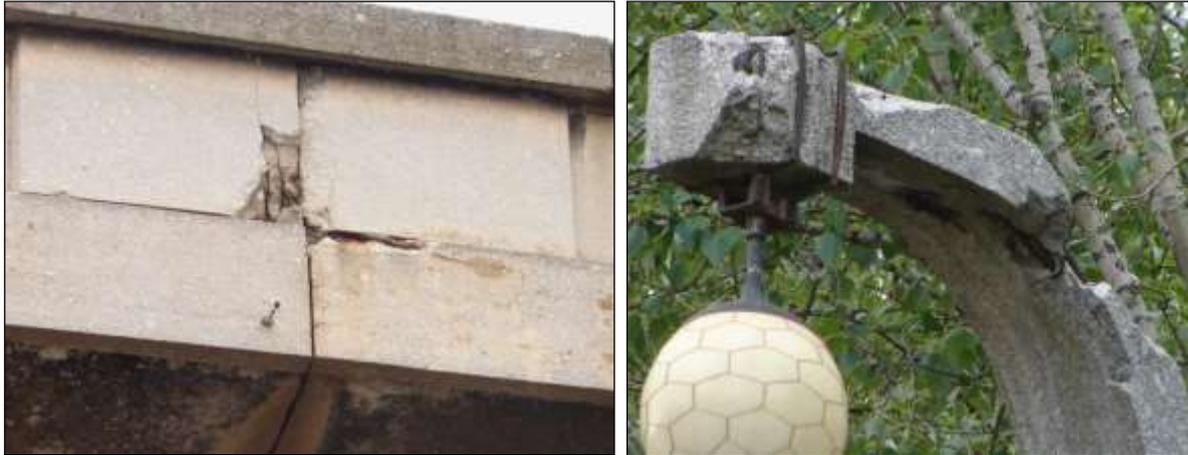
- 6) **Construction elements of the ornamental surface concrete layer** (used in the architectural elements) have much better properties in terms of durability. In contrast to the concrete used for construction, the ornamental concrete layer has fewer divisions (with the exception of the staircases and the upper side of the cantilevered columns and abutments). There are numerous cracks, especially in the area of the cantilevers and cantilevered parts of the columns and abutments. Parts of railings and historical decorative street lamp posts show signs of considerable damage (broken edges, cracks).

**Fig. 12 and 13:** Damage in the railings and cantilevers in the upper part of the vault caused primarily by dilation. Damage of the street lamp post caused by reinforcement corrosion and weather conditions

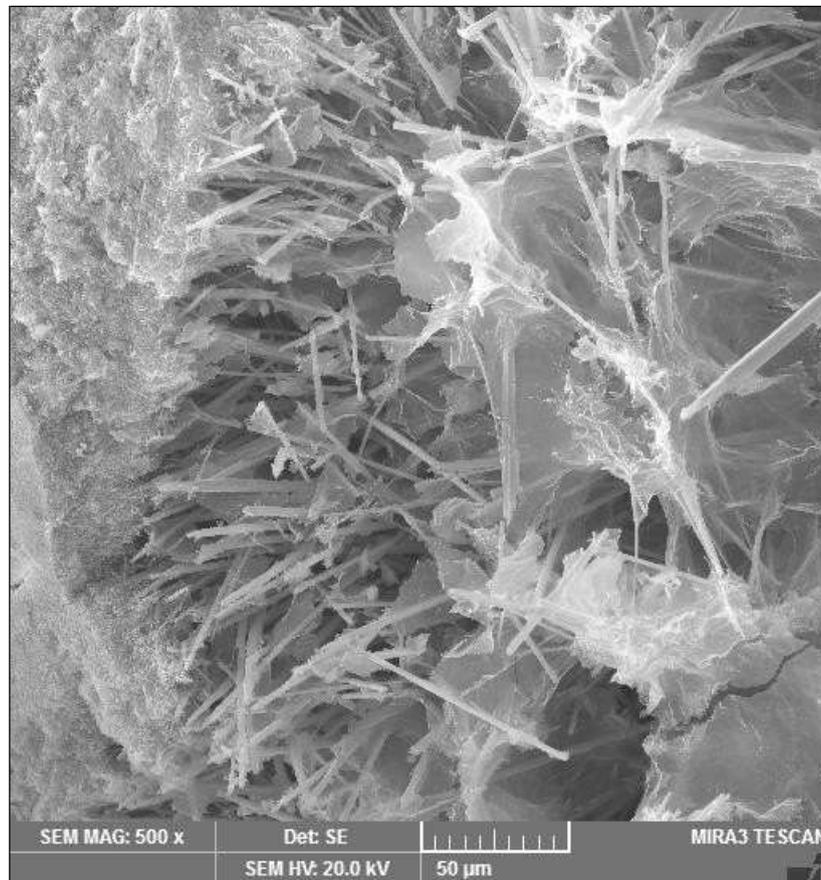
- 4) **The foundations of the vault part, columns and abutments** (up to the bottom joints of the vaults) **suffer from internal sulphate corrosion**. The inspections have shown that the concrete's micro-structure has not yet been severely affected. If it was the case, it would have acutely decreased its strength. As a result, the progression of sulphate corrosion is very slow and **does not constitute an imminent danger** (no significant decrease in the load-bearing capacity due to degradation of the concrete's mechanical properties was observed). **Gradual degradation cannot however be excluded** and if the structures are to remain in place, they must be periodically inspected and monitored in the long term. Sulphate corrosion has attacked the foundations of the frame structures. The severity of the attack is however significantly lower than in the vault part of the bridge.

**Fig. 14:** Ettringite in the foundations of the column of the vault part (formed as a result of sulphate corrosion in concrete)

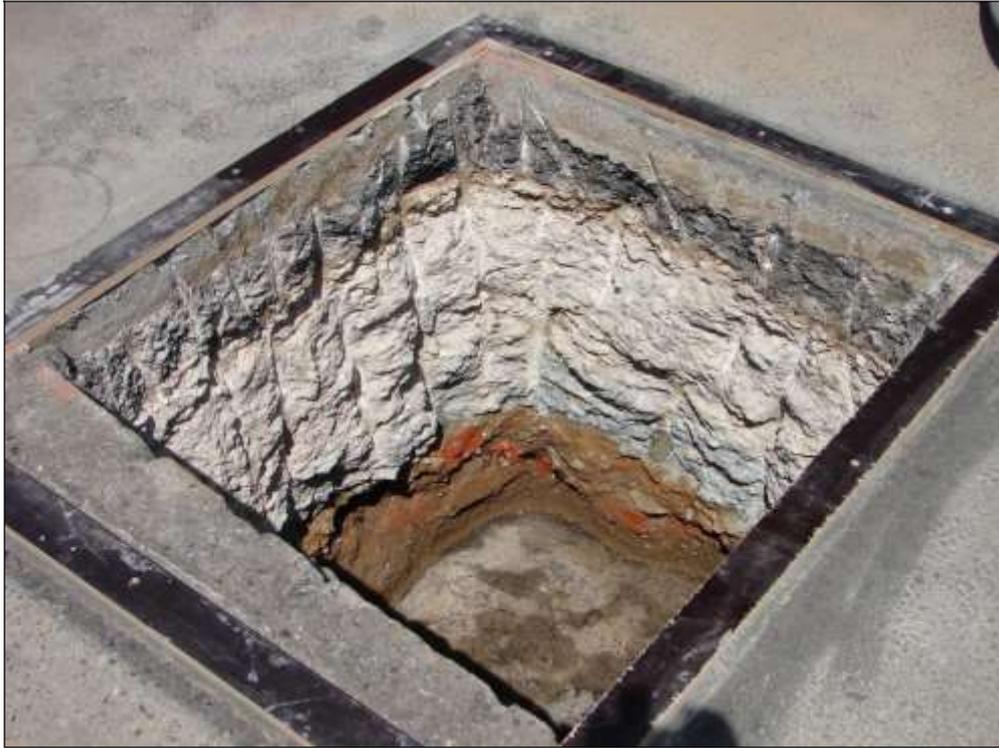
- f) The backfills of the vault part of the bridge are composed of river sands, gravel sands, gravels and building debris consisting predominantly of bricks. The backfills contain only low levels of water-soluble salts, so their influence on degradation can be considered as negligible. The density of backfills recommended for static analysis is 1900 kg/m<sup>3</sup>.

**Fig 15:** Concrete layers underneath the roadway of the vault part and backfill consisting of gravel sands and building debris

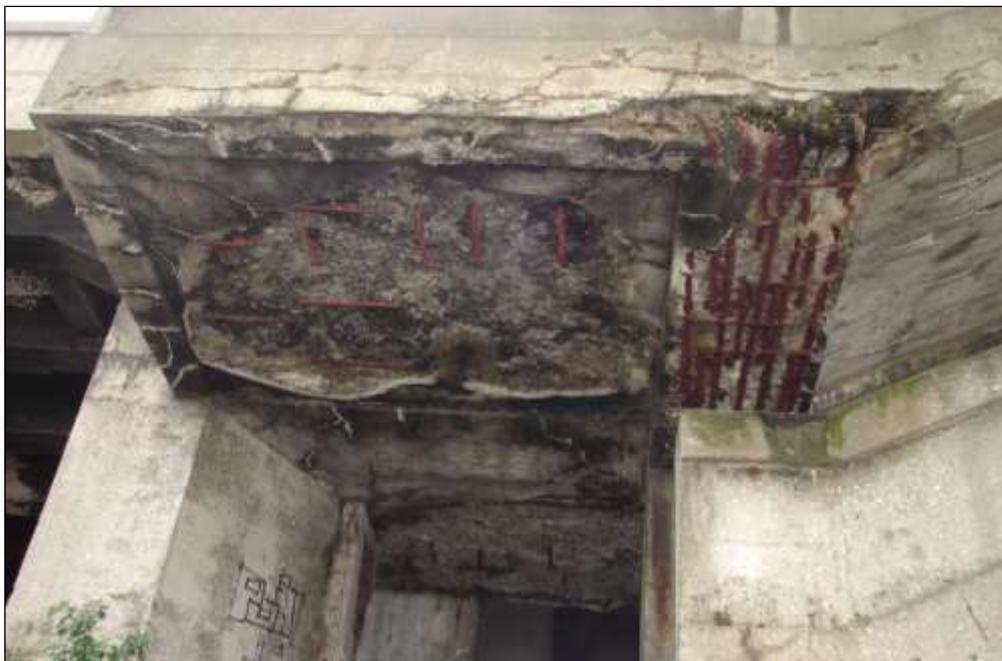
- 5) **The staircase structures are in an emergency condition** (weakened reinforcement, profound and locally complete degradation and disintegration). They must be replaced.

**Fig. 16:** Staircases; weakened reinforcement and deep degradation of concrete - emergency condition

The conducted diagnostic inspections have concluded that the staircases are in irreparable condition. This part was not subjected to static assessment.

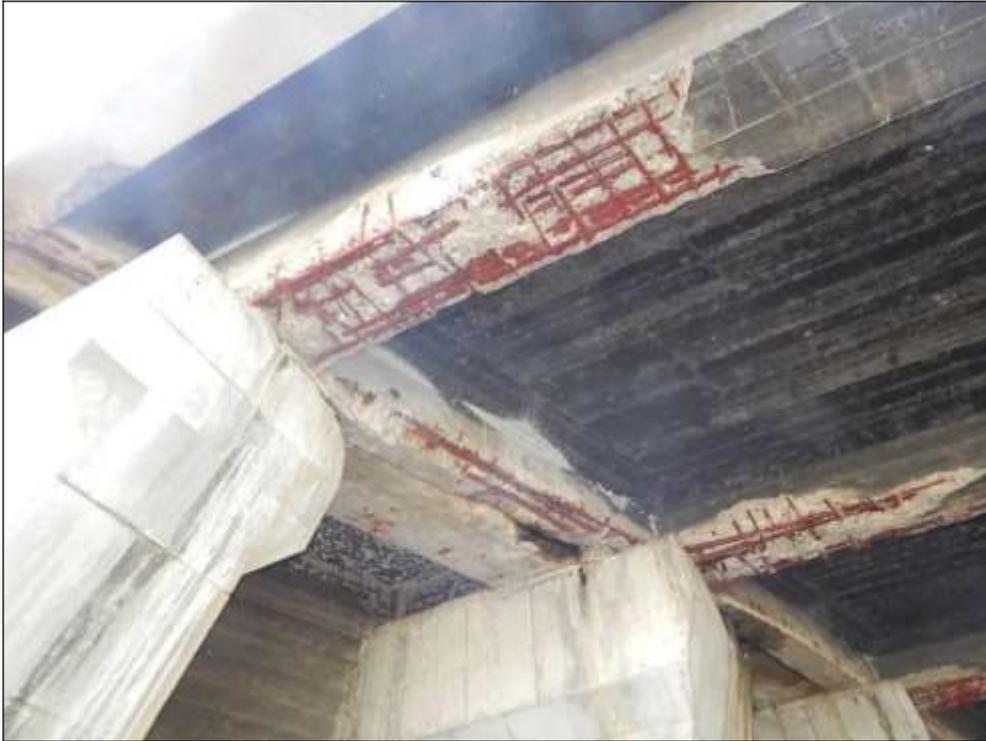
- 3) **Parts of the frame structures' decks around the expansion and deck joints are in an emergency condition**. In the frame of the Holešovice side, this includes areas around the longitudinal expansion joints of frame fields RP1 and RPF2 (frame part A) and areas around the joints of frame fields RP3 and RP5 (frame part I-VI). In the frame of the Libeň side, this includes the longitudinal expansion joints of frame field RP13 (frame part C). The detected damage has a critical impact on the load-bearing capacity and static reliability (weakened reinforcement and deeply penetrated degradation).

**Fig. 17:** Frame structure; Holešovice frame part, part I-VI in the joint area; weakened reinforcement and deep degradation of concrete - emergency condition

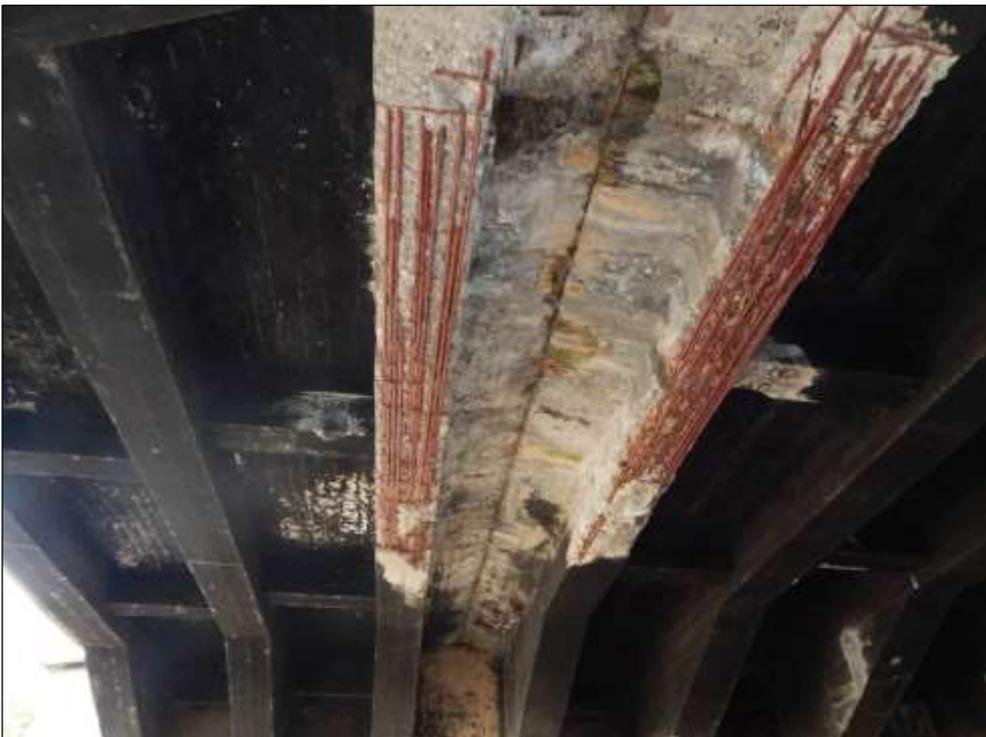
**Fig. 18:** Frame structure; Libeň frame part, part C in the area along the expansion joint; weakened reinforcement and deep degradation of concrete - emergency condition

- 2) The frame structures on both sides are the weakest parts of the bridge.
- 3) Frame part C located on the Libeň side near the railing is in the worst condition. The reinforcement structure lost 40 % of its cross-section area due to corrosion. The normal permissible load of frame part C is  **$V_n = 5 \text{ t}$  when tramway traffic is interrupted.**

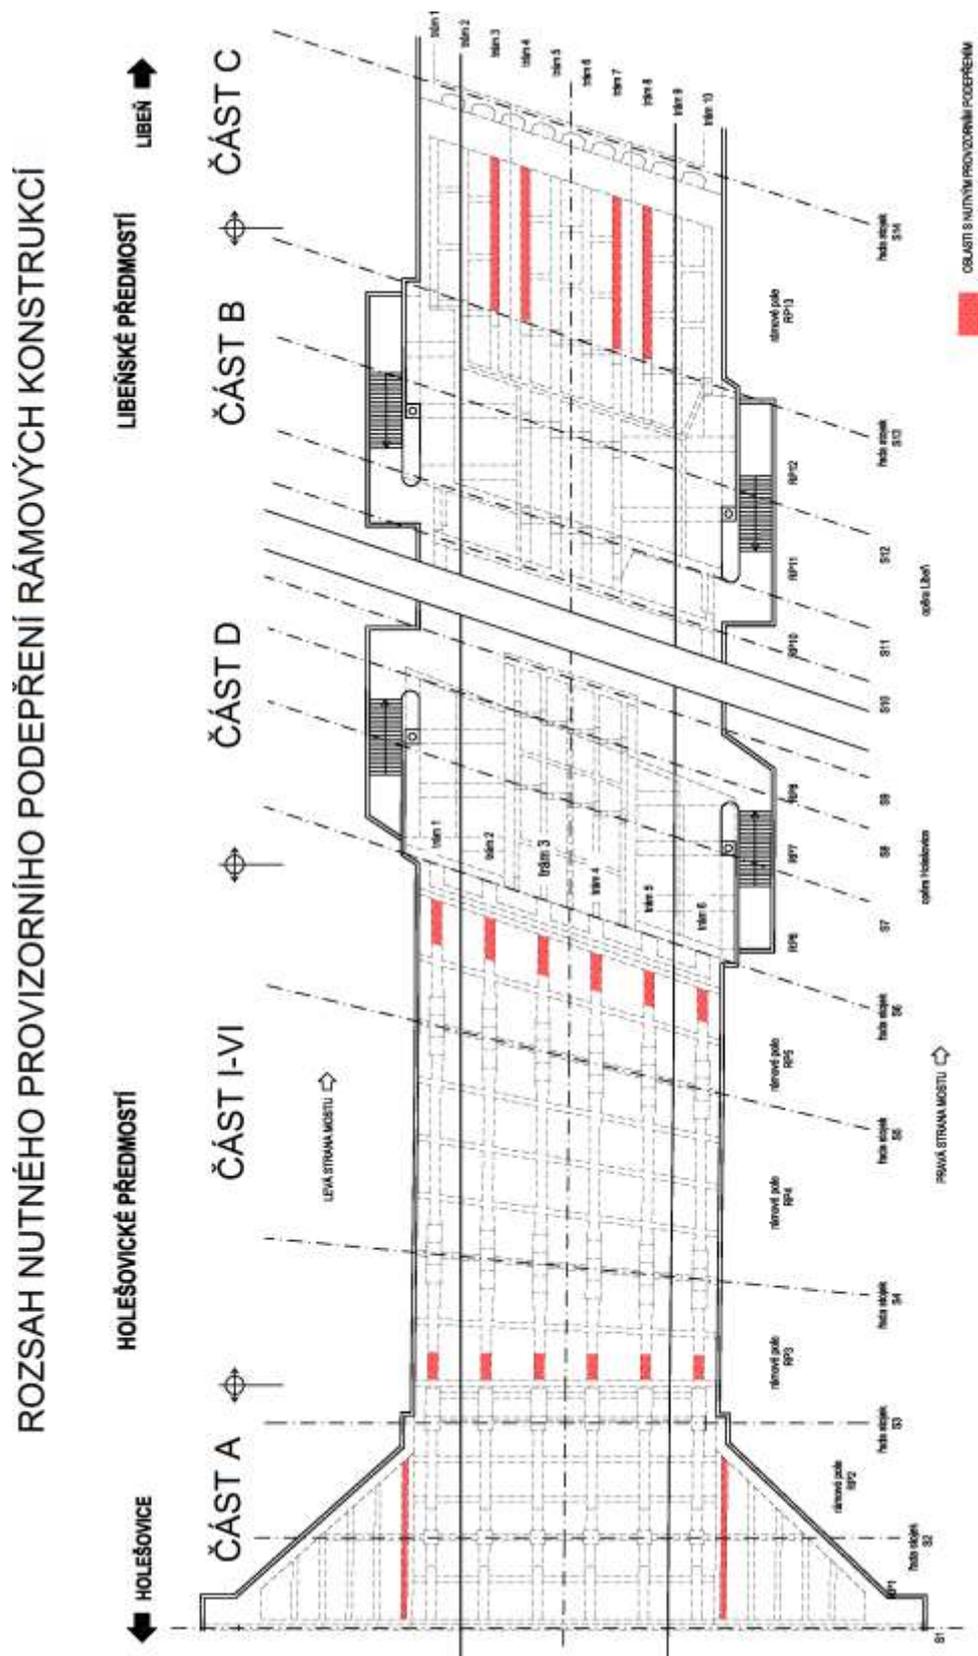
**Given the emergency condition of several frame structures, the operation of tramways must be interrupted until a temporary support system is installed (Fig. 21).** It is necessary to make sure that the loadability does not exceed 5 t in case of a sudden change.

**Fig. 21:** The extent of the necessary temporary support structures of the frame parts to allow for the normal permissible load of 11 tons at maximum for each direction of road traffic and alternating tramway traffic

- 4) **The bridge is in an emergency condition.**
- 5) To enable a safe one-way tramway operation on the bridge until a final solution is found and realised (reconstruction or construction of a new bridge), a temporary support system must be established to support several cross sections of the frames (see Fig. 21).

- 6) **After the most damaged frame parts are supported with additional structures, alternating traffic** (real tramways T14 and T15 were taken into consideration) **must be implemented for tramways operating above frame part B and the loadability of road vehicles must be limited to  $V_n = 11 \text{ t}$  over the entire bridge V009.**
