## **Libeň Bridge (V009) Society**

**Expert report No. 1700 J 019-01**

**Determination of Loadability of Libeň Bridge V009 and Assessment of Individual  
Construction Elements in Terms of Feasibility, Applicability, Service Life and Potential  
Repair Works**

**SUMMARY REPORT**

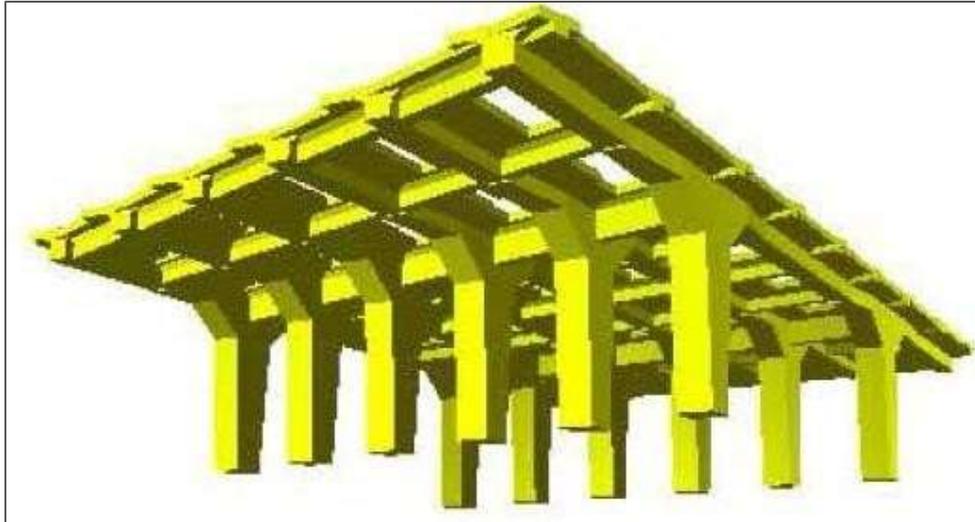
**Fig 20:** Calculation model to determine the loadability of the frame part (part I-VI)

**Based on the results obtained by the static analysis, it can be assumed that frame part C in its current state has the lowest loadability values. Without any tramway traffic operations, its normal loadability is  $V_n = 5\text{ t}$ .**

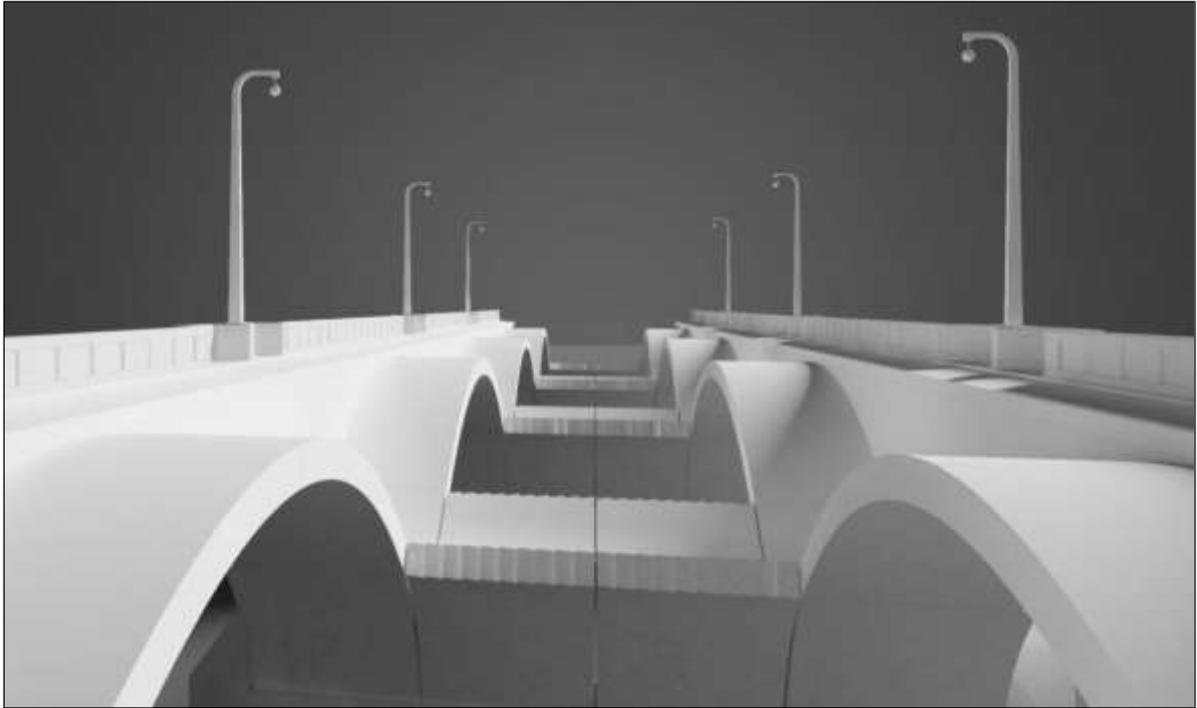
**Fig. 22:** View of the bridge after the removal of the inner vault strips

- 10) **The reconstruction of the vault part, including stabilisation works in the foundations, will be highly demanding both in terms of the preparatory design works and the implementation.** The technical design presented in this report is solely theoretical, not accounting for a number of legal aspects (impact on the current construction permit) and technical details (solution of networks, connected buildings and roads).

The following figures illustrate the concept of the inner vault strip replacement.

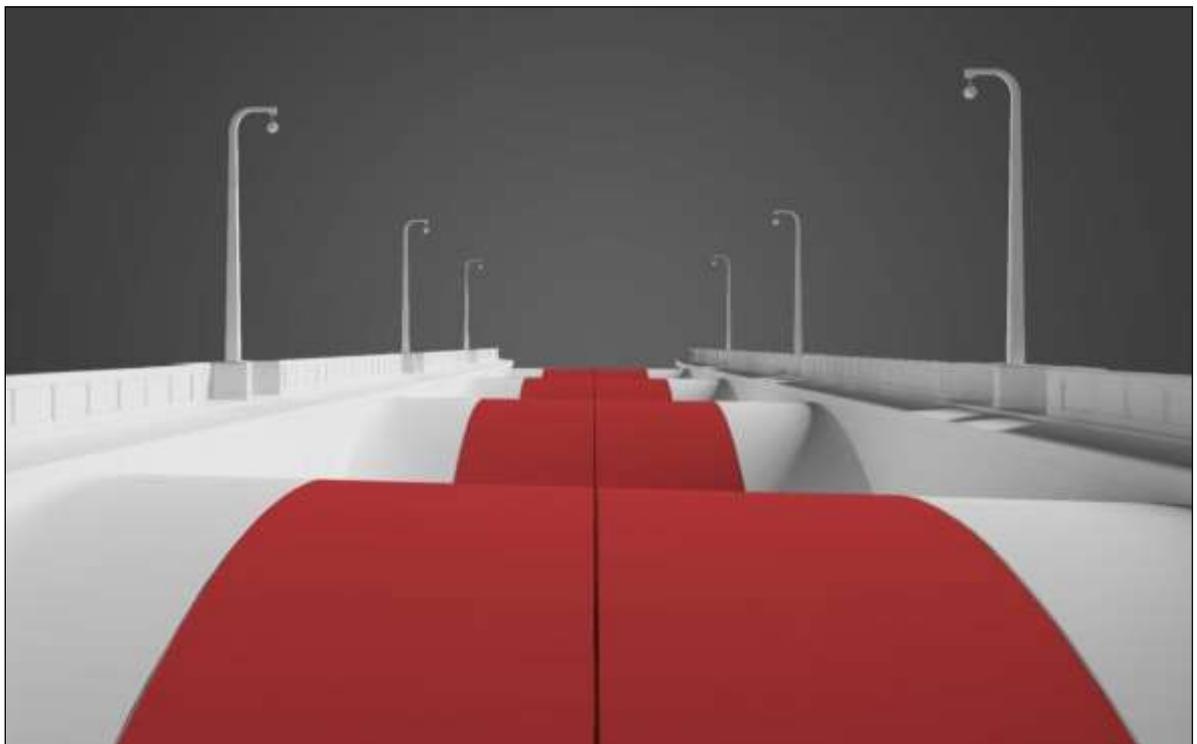
**Fig. 23:** View of the bridge with new reinforced concrete three-joint vault strips
